# **APPLYING STATOR END-WINDING VIBRATION MONITORING TECHNOLOGY AT J.H. CAMPBELL GENERATION PLANT**

Jackson Lin  
Sales Engineer, VibroSystM Inc.  
Longueuil, QC Canada

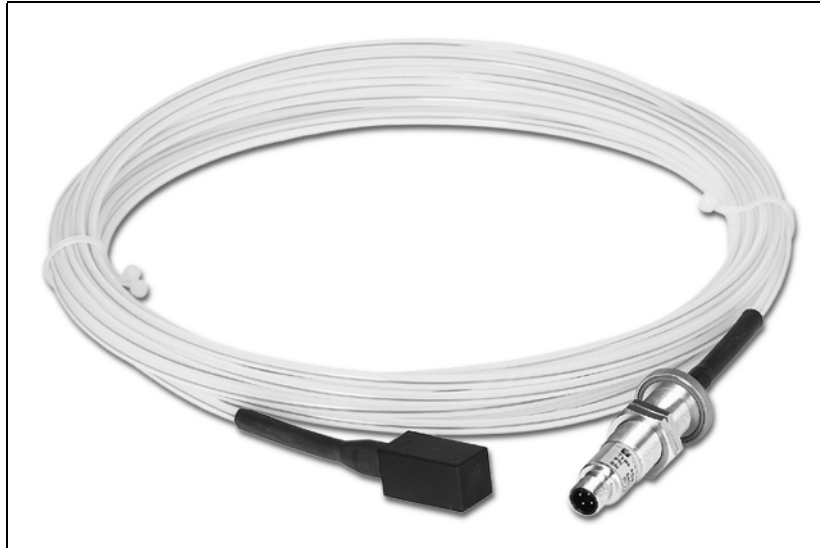
FIGURE 1 – Unibody FOA-100 Fiber Optic Accelerometer with ceramic sensor head, 10-m optical cable, and sealed feedthrough connector with built-in optoelectronic conditioner.

The accelerometer operates on a method of light reflection from a mirror mounted at the end of a cantilever beam inside the accelerometer head. The rate of change in the intensity of deflected light detected by the optoelectronics of the integral feedthrough/signal conditioner is deciphered to determine the proportional acceleration. The output of the FOA-100 signal conditioner is 100 mV/g, a standard for general purpose accelerometers. Therefore, this accelerometer is fully compatible with any common vibration analyzer or on-line vibration monitor.

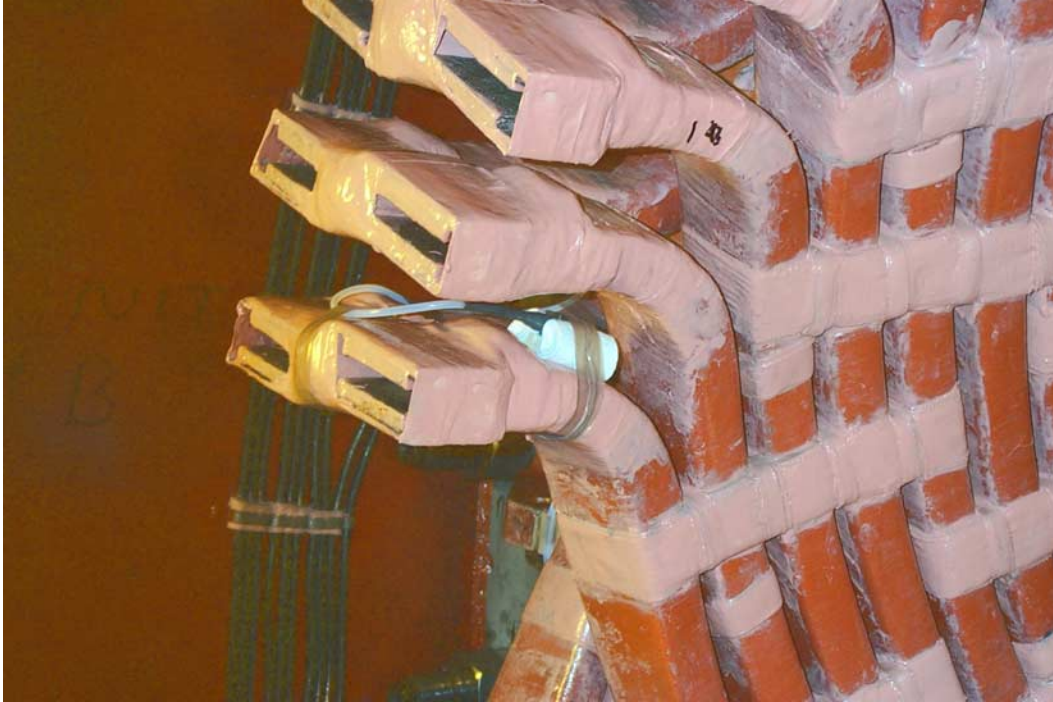
FIGURE 2 – Sensor head and optical cable temporarily secured to the end-winding

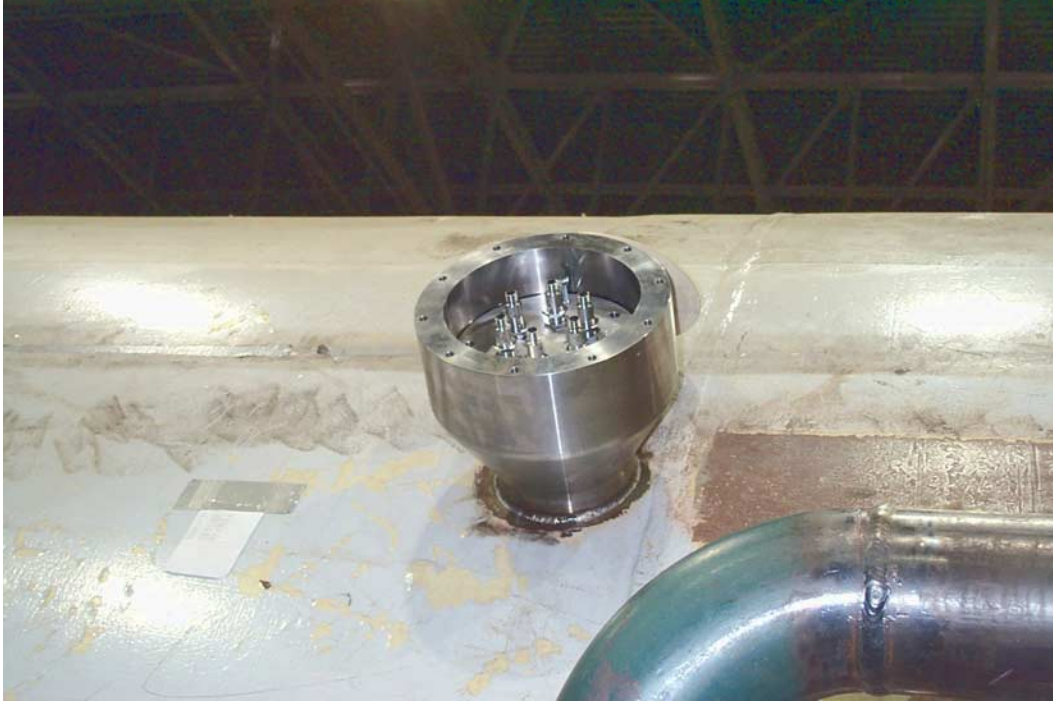
FIGURE 3 – Sealed flange welded on the generator casing with feedthrough connectors ready to connect. When external instrumentation is not connected, a sealed plate is placed over the opening to provide additional security

Major considerations for installing FOA-100 accelerometers are maintaining fiber optic cable bending radius, ensuring a hydrogen sealed flange for safe signal exit and establishing a rigid coupling between the end-winding and accelerometer. The minimum bending radius of 3.15-inch of the fibre optic cable must be respected since the fiber optic cable would otherwise be damaged and jeopardize the accuracy of the readings. A special metallic flange had been manufactured to permit the routing of the fiber optic cable through the generator casing [see FIGURE 3] and permit the safe transfer of vibration signals from the hydrogen environment (explosion-risk zone) to the ambient air (safe-zone). This flange permits the easy connection of portable vibration analyzers from the safe-zone without risking a leak in the generator cover. Finally, special care must be taken during the installation of the accelerometer to minimize any dampening of the motion of the end-windings. These considerations include ensuring the installation of the FOA-100 in the correct sensitive axis and verifying the epoxy & taping between the FOA-100 and the end-winding [see FIGURE 4].

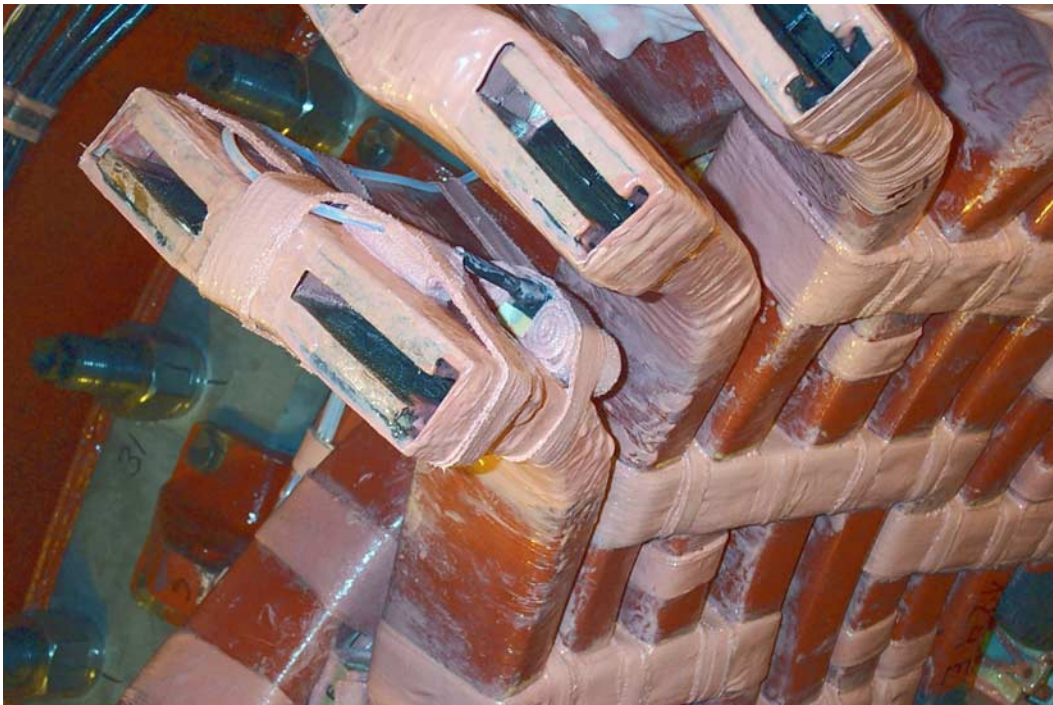
FIGURE 4 – Final installation of the sensor head and optical cable with same impregnated material used to brace the end-windings
